North Sea small scale mineral deposition tests

DCE Technical Report No 272.

December 2019

This report has been prepared by Lucia Margheritini under the investigations financed by the EUDP project “New material for wave energy substructures” (<https://www.civil.aau.dk/Project+websites/newmaterialwes/?page=1>).

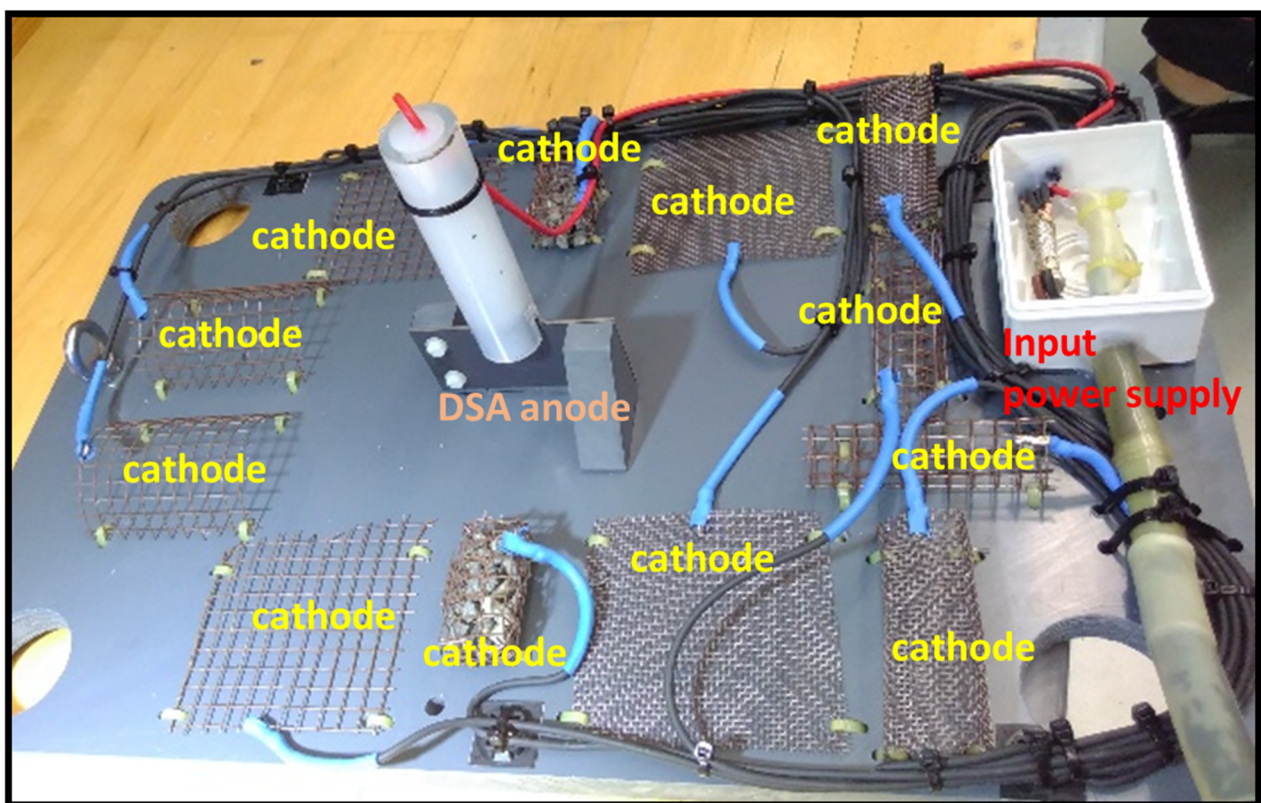
Figur 1. Setup previous installation.

The set up in Hantholm consisted of a self-contained hard plastic box adequately perforated to allow water circulation, containing the 6 sets of cathodes (2 par shape, all weighted), anode, HOBO data logger and secured connections. The entire electrode setup fitted the bottom of the box over an area of circa $0.55 \times 0.38 = 0.21$ sqm. The cathodes were placed around the anode at an average distance of circa 16 cm from centroids. All electrical connection were isolated and the anode connection waterproof (silicon) (Fig. 1).

The cathodes are connected to the negative pole and the anode to the positive. A water proof box hosted the split connections.

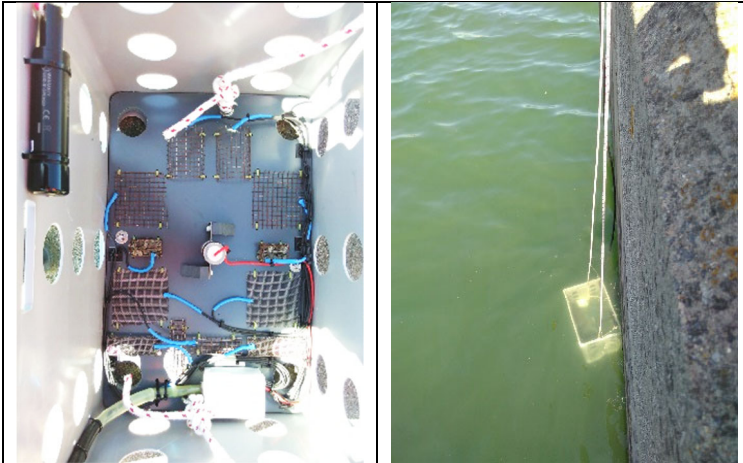
Figur 2. Hanstholm setup at location.

The setup was lowered circa 20 cm above the sea bottom at - 5 m below surface with a rope. The “suspended solution” was chosen in order to try to avoid massive deposition of fine particles over the electrodes, typically occurring in harbours (but unfortunately, it did not serve the purpose), (Fig 2). The lowering was monitored with an underwater camera with led lights. Visibility is generally very poor, almost complete darkness at 5 m depth. Marine life seem to be abundant and identifications of anemones, crabs and fish could be done.

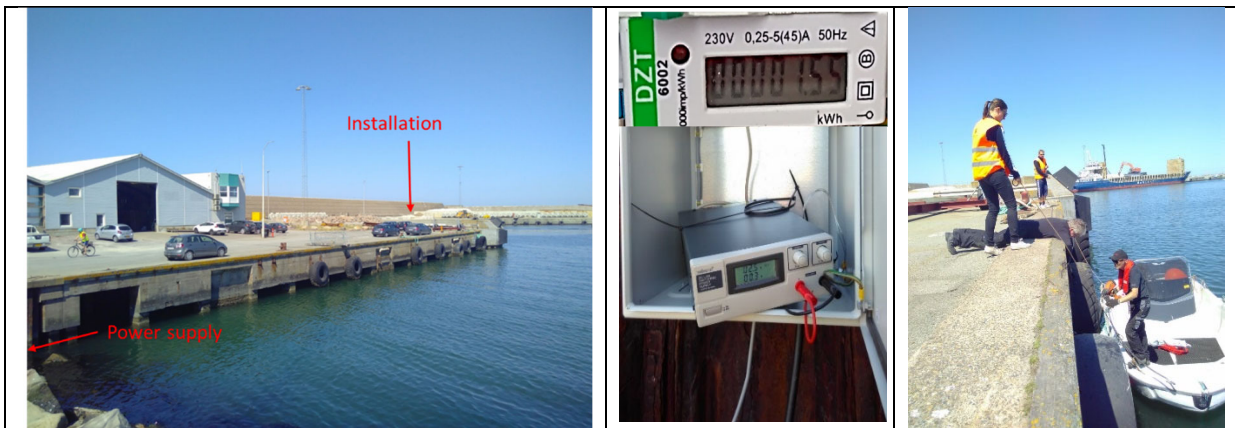
Figur 3. Overview of installation at Hanstholm Harbour.

Once in the water, a V pf 5 – 5.5 was applied for few seconds until bubbling, and after the voltage was set to 2.5 V, corresponding to 0.3 A. The power was sourced from the electrical grid from a pole 100 m away

from the installation (Fig 3). Power consumption was monitored. The test were run at constant 2.5 V. The current was initially 0.3 A and then shifted to 0.2 A till the end of the tests (Fig. 3).

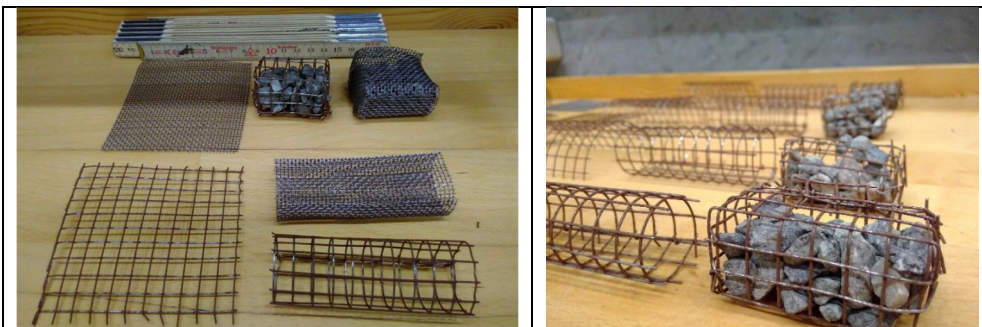
Figur 4. Cathodes for Hanstholm installation.

The cathodes were pieces of circa 10x10 cm of metal grid and net shaped by hand into cylinders and blocks (Fig 4). The cathodes materials, untreated steel, have the characteristics in Table 3.

<p><i>FINE GRID</i></p> <p>Maske 8,5 mm Tråd 0,8 mm</p> <p>Maske: 8,5 x 8,5 mm</p> <p>Tråddykkelse: 0,8 mm</p> <p>Bredde: 1000 mm</p> <p>Materiale: Ubh stål</p>	<p><i>WIDE GRID</i></p> <p>Maske 1,6 Tråd 0,5</p> <p>Maske: 1,6 x 1,6 mm</p> <p>Tråddykkelse: 0,5 x 0,5 mm</p> <p>Mesh: 12 x 12</p> <p>Åbent areal: 58</p> <p>Bredde: 1020</p> <p>Vægt (kg/m²): 1,527</p> <p>Materiale: Ubh stål</p>
--	---

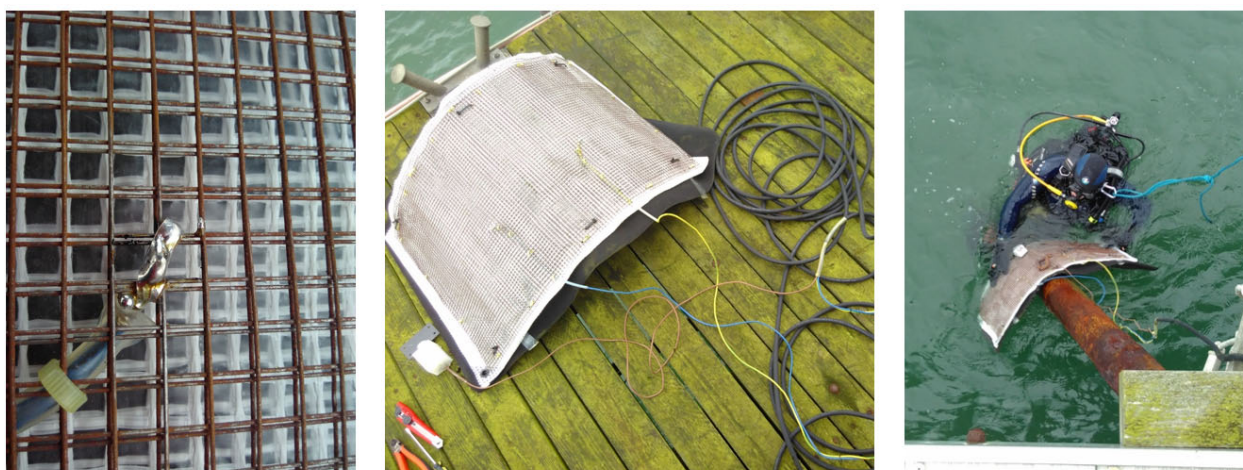
Figur 5. Electrodes installation at Nisum Bredning

The set up in Nisum Bredning consisted of a mesh of circa 1x1 sqm of the small mesh kind in Table 3 as a cathode. The mesh was secured around one of the poles/legs of the bridge. A thick rubber insulation made of a black and white layers of several mm was placed between the cathode and the metal leg of the bridge in order to avoid electrical connections. The anode was 9.5 x 4.6 x 0.2 cm DSA provided by Electrocell, with waterproof connection (silicon) (Fig. 5). The tests were set to run with constant 2.5 V. the current at installation was then 0.449 A.

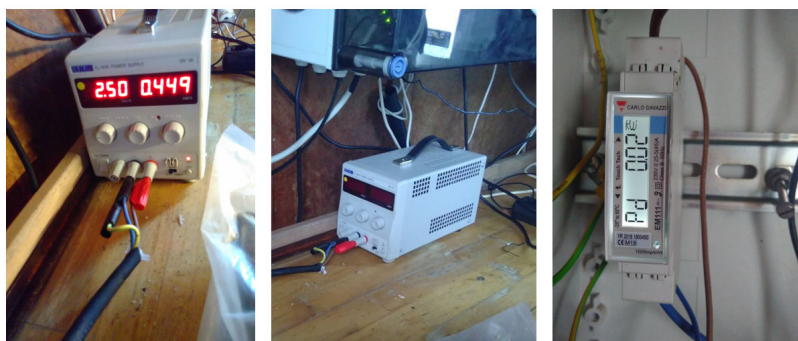
Figure 6. The power supply at installation (lf) and on the day of decommission with indication of energy consumption (ce and rt).

Few meters (4-6) of cables were connecting the electrodes to the power supply inside the protected DanWEC container. Power consumption was monitored. Unfortunately, as mentioned in chapter 3, a shortcut occurred few days after installation and the overall power consumption was only 0.02 kWh (Fig. 6). This also means that the setup was never properly running. Regretfully, even when we indicated to DanWEC that there was no power flowing to the cathode, they did not do anything to reestablish the necessary conditions for the tests. This accident, and the later storm that damaged the bridge making it impossible for us to go there, led to the decision of decommissioning (Fig. 7). Without the protection of the electric current, the cathode rusted as expected (Fig. 8).

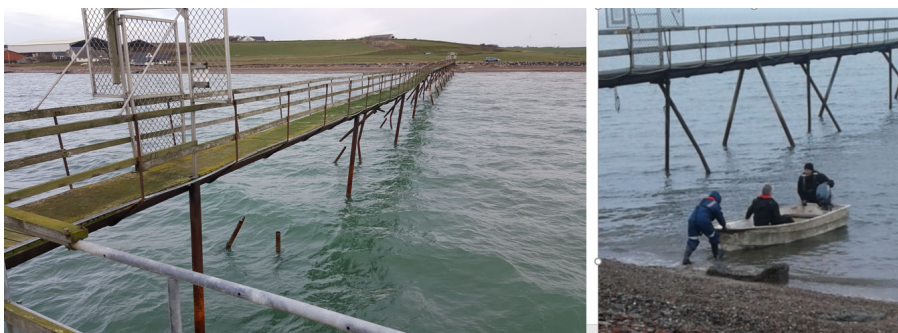
Figur 7. Nissum Bredning damaged bridge

Therefore, while the tests in Hanstholm could be considered successful, the ones in DanWEC did not. Aggravating the DanWEC situation, is the fact that after the storm that damaged the access bridge, we received pictures of the installation, from which we deduced no power was flowing (evident rust). We got a warning not to go there as the bridge was hazardous but we did make clear there was no power. Despite this, no one from DanWEC went to re-establish power connections. Once we reached DanWEC on the 07 of March with our own electrician, we could see that there had been a power shortcut at location only few days after installation, as the power consumption measurements where close to zero. Regretfully, despite the promising installation, it resulted in aborted tests and loss of money as we did pay the access but did not received the granted service of electricity supply and also had to pay for decommission, even if the contract stated that in case of failure of the facility, the decommission would be covered by DanWEC.

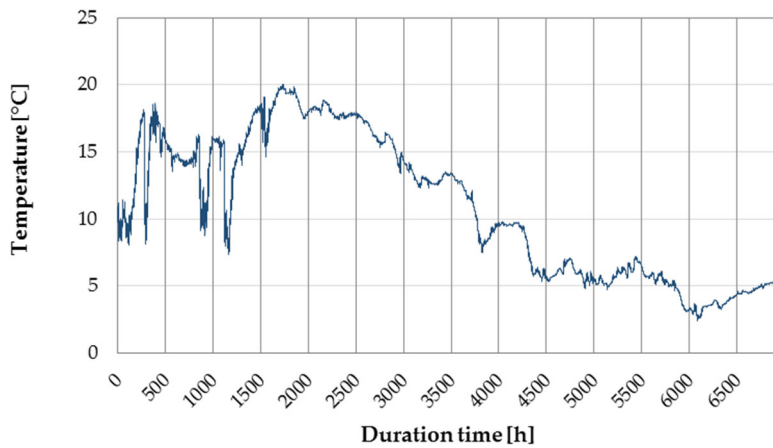
Figur 9. Water Temperatures from 24th of May 2018, 1:30 PM, to the 7th of March 2019 1:00 PM

The data logger for salinity and temperature was installed in the setup. Continuous measurements are therefore available from installation besides malfunctioning of the instrument. The logger recorded the temperatures and conductivity of the water in the exact setup every 30 minutes during installation, for a total of circa 13770 data points each.

The maximum and minimum temperatures recorder were 20.0 °C and 2.4 °C respectively.

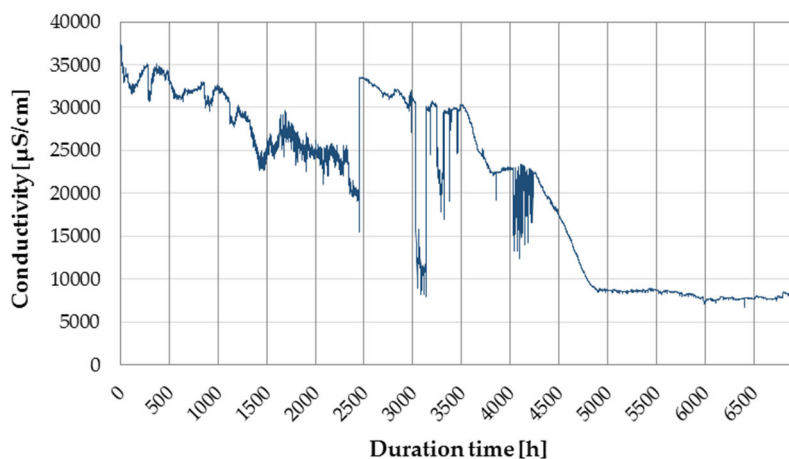
Figur 10. Water Temperatures from 24th of May 2018, 1:30 PM, to the 7th of March 2019 1:00 PM

The maximum and minimum conductivities recorded were 37530 and 6666 $\mu\text{S}/\text{cm}$.

The harbor can be considered a small basin of water and rain can influence the salinity. Additionally, bio-fouling might have affected the conductivity measures in the last 3 months of testing.

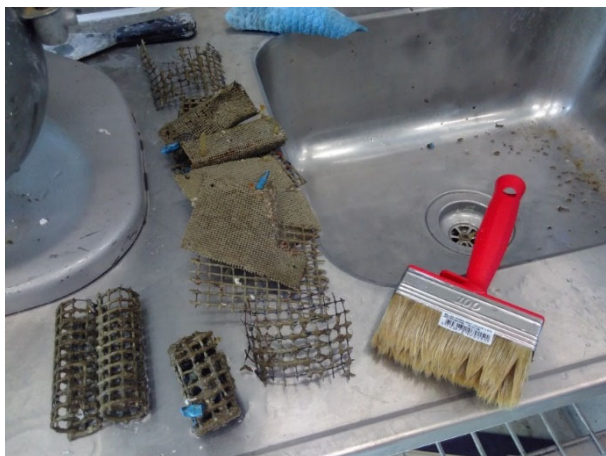
Figur 11.

The layer of deposited material was between 2-7 mm depending on location, showing thicker deposition where the meshes on the cathodes intersect. The material was also easily detached from the cathode.

The cathodes were removed for the setup and washed in the laboratory. Suspended material was removed with a soft brush.

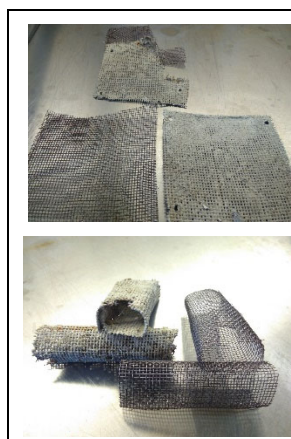
Tabel 5

FINE GRID				
Squared shape, plates				
sides 1 [cm]	side 2 [cm]	weight before [gr]	weight after [gr]	Gain [gr]
9,5	10	13,25	27,97	14,72
Squared section, columns				
10		13,5	26,41	12,91

After this time, the cathodes have been weighted and a comparison with weight before mineral deposition has been made to calculate the weight of the deposited material (Tables 5-7). The results are presented divided by the mesh types.

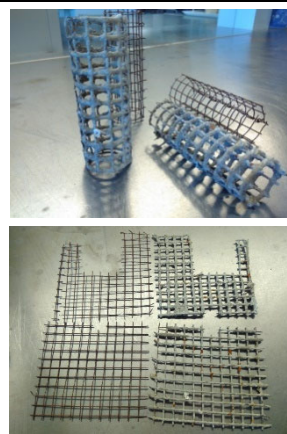
Tabel 6

WIDE GRID				
Squared shape, plates				
sides 1 [cm]	side 2 [cm]	weight before [gr]	weight after [gr]	Gain [gr]
9,5	10	9,0	17,3	8,3
Round section, columns				
9,5	3	8,5	20,43	11,93
